**RICHVILLE DAM
VT 00074**

**PHASE I INSPECTION REPORT
NATIONAL DAM INSPECTION PROGRAM**

Identification No.: VT00074
Name of Dam: Richville Dam
Town: Shoreham
County and State: Addison County, Vermont
Stream: Lemon Fair River
Date of Inspection: August 2, 1978

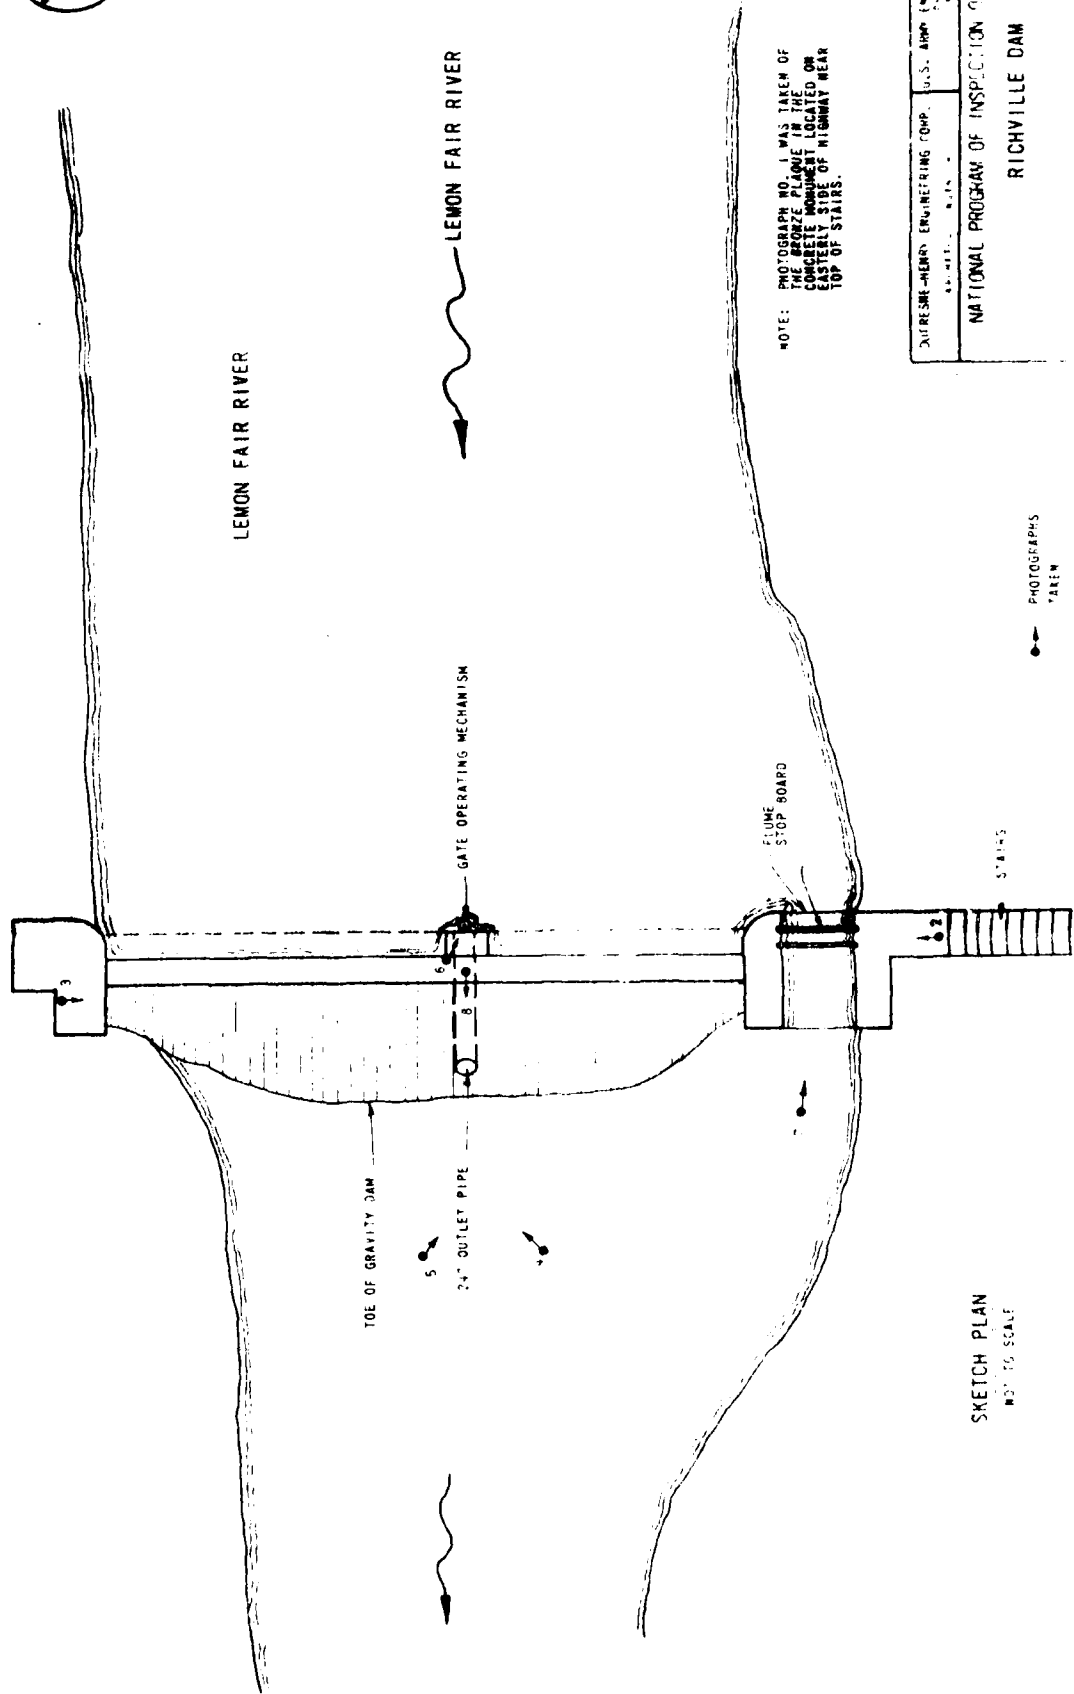
NOTE: PHOTOGRAPH NO. 1 WAS TAKEN OF THE BRIDGE PLANE IN THE CENTER OF THE DAM. THE BRIDGE WAS LOCATED ON THE TOP OF STAIRS.
